**Asbestos Abatement and Removal Site Demolition and Grading for 738 Center Street (TMS# 004638-02-010)**

Project: Asbestos Testing  
738 Center Street  
West Columbia, SC 29169

## I. Agreement / Asbestos Inspector's Signature

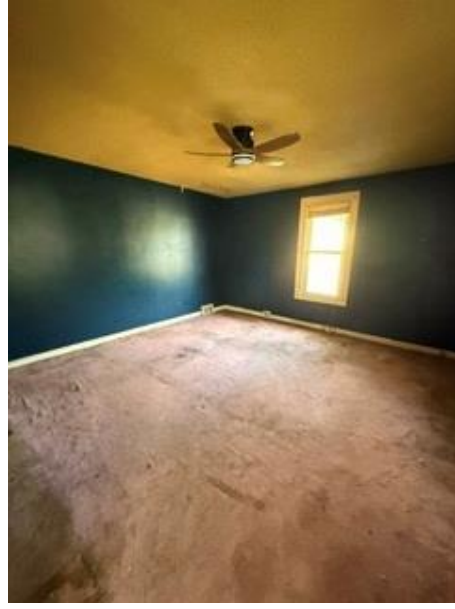
| Suspect Mat. No. | Material Description | Cat. (S,T,M) | Location | Present Cond. | Quantity | Percent Asbestos | Analysis Method |
|---|---|---|---|---|---|---|---|
| 1A-G | Drywall/Joint Compound | M/S | Throughout the Home (behind paneling in kitchen/dining) | G/F | 1500 sq ft | 2% Chrysotile | PLM<br>EPA/600/R-93/116 |
| 2A-C | Textured Ceiling | S | Kitchen, Living, and Bedroom | G/F | 1000 sq ft | 3% Chrysotile | PLM<br>EPA/600/R-93/116 |

Bedroom – texture ceiling (SM2) and sheetrock walls (SM1)

These materials must be removed by a licensed asbestos abatement contractor in accordance with EPA, SCDES and OSHA regulations prior to demolition or renovation activities beginning.

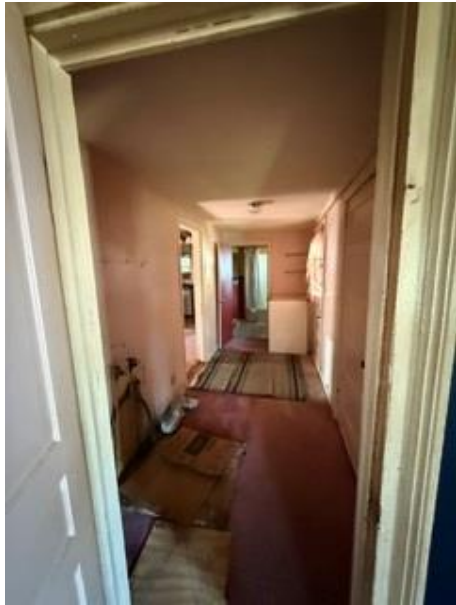
| Suspect Mat. No. | Material Description | Cat. (S,T,M) | Location | Present Cond. | Quantity | Percent Asbestos | Analysis Method |
|---|---|---|---|---|---|---|---|
| 5A-C | Textured Ceiling | S | Hallway | G/F | 80 sq ft | 3% Chrysotile | PLM<br>EPA/600/R-93/116 |

Hallway – texture ceiling (SM5) and sheetrock walls (SM1)

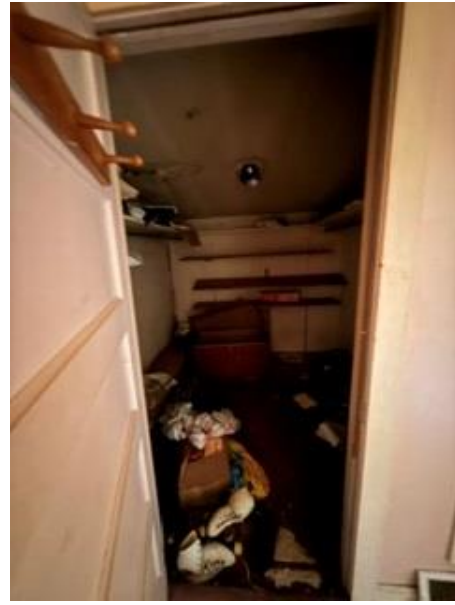
Hallway Closet – texture ceiling (SM2) and sheetrock walls (SM1)

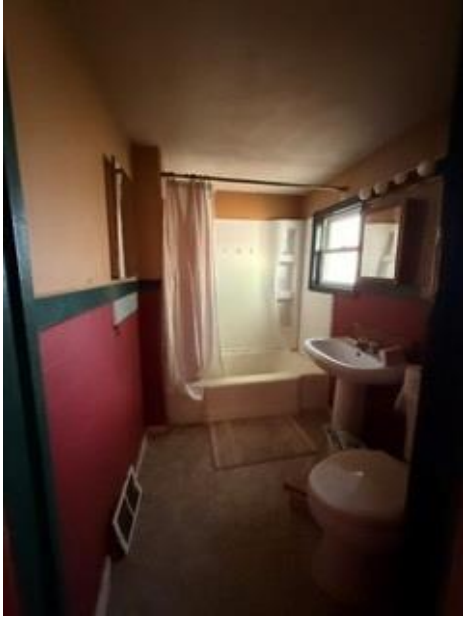
Bathroom - texture ceiling and sheetrock walls

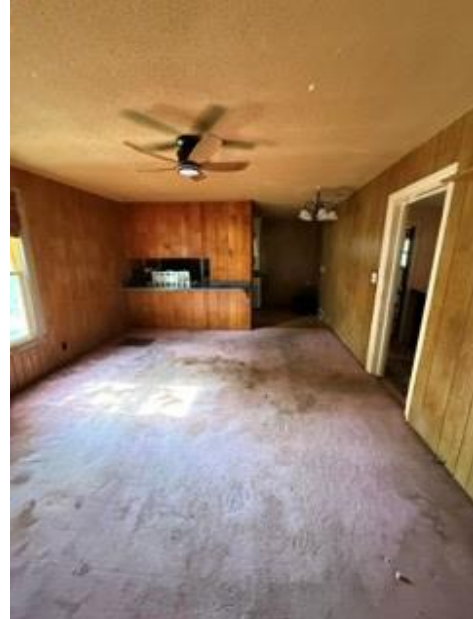
Kitchen - texture ceiling and sheetrock walls

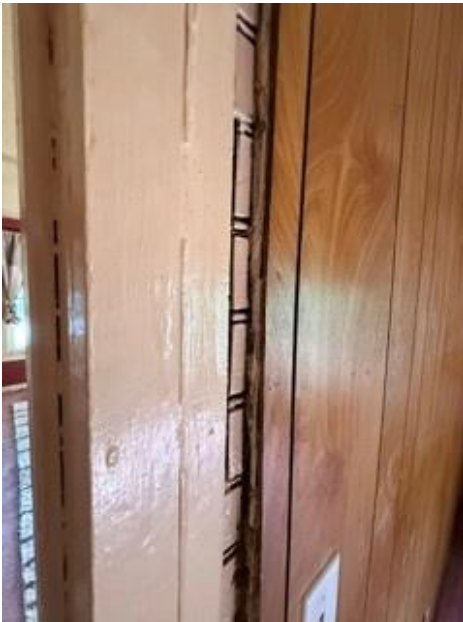
Kitchen Paneling over sheetrock (SM1)

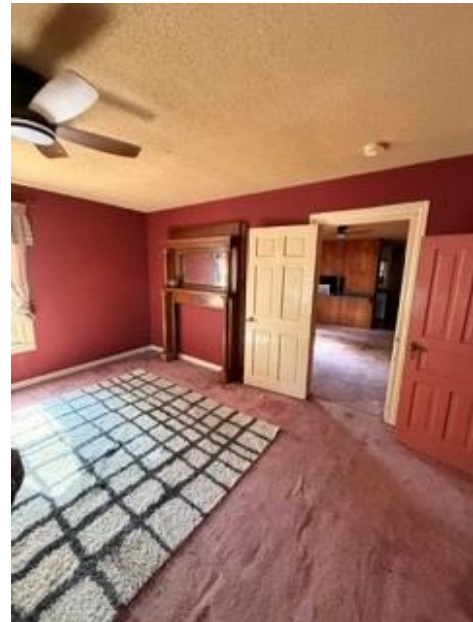
Living Room - texture ceiling and sheetrock walls

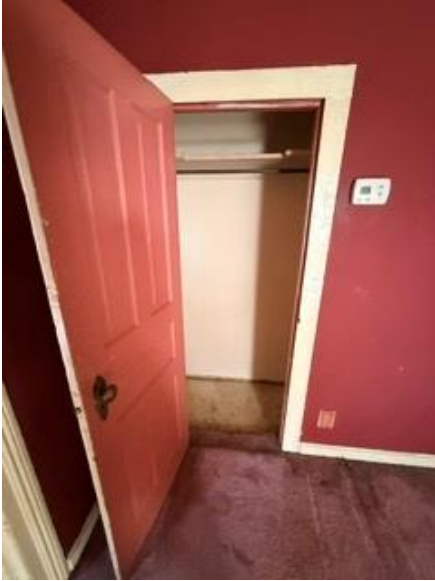
Living Room Closet - texture ceiling and sheetrock walls

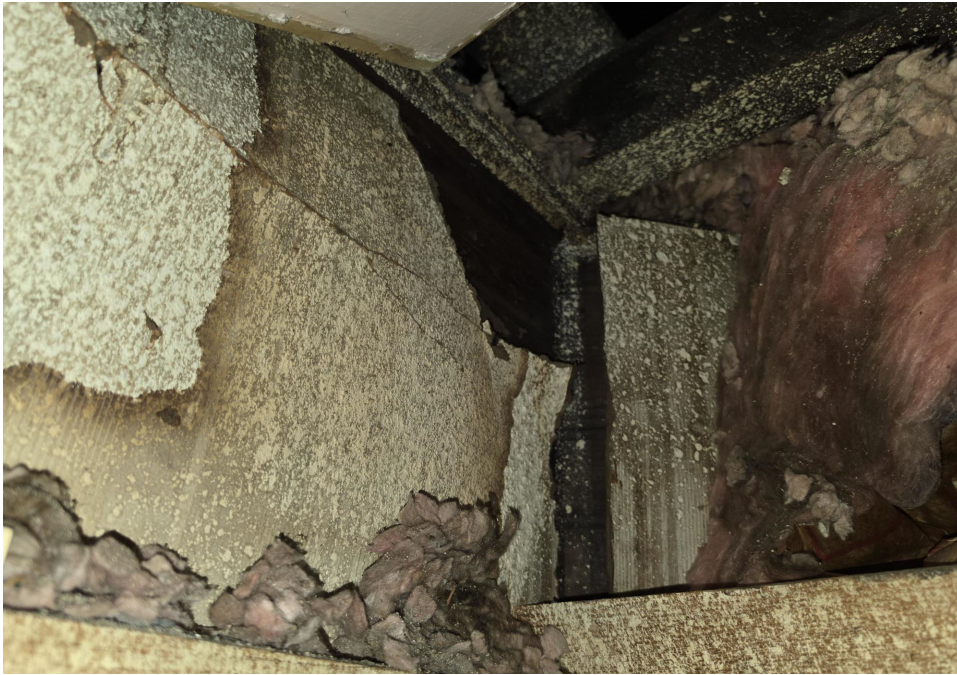
| 11A-C | Paper | M | Behind Exterior Walls | G/F | 1200 sq ft | 2% Chrysotile | PLM<br>EPA/600/R-93/116 |

The following materials were identified as having more than 1% asbestos: paper behind exterior wall, exterior pipe caulking, textured ceiling throughout the home, and the drywall/joint compound in the wall system throughout the home.

SM11 - 2% chrysotile

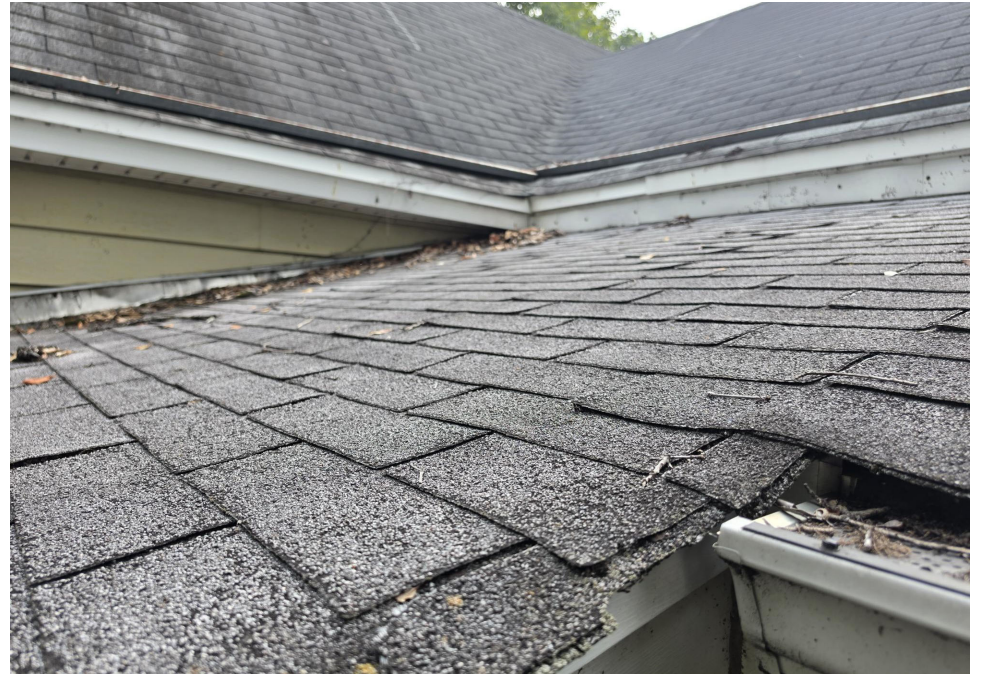
| Suspect Mat. No. | Material Description | Cat. (S,T,M) | Location | Present Cond. | Quantity | Percent Asbestos | Analysis Method |
|---|---|---|---|---|---|---|---|
| 6A-C | Roofing | M | Roof of Home | G/NF | 1080 sq ft | None Detected | PLM<br>EPA/600/R-93/116<br>& TEM |

SM6 - roofing

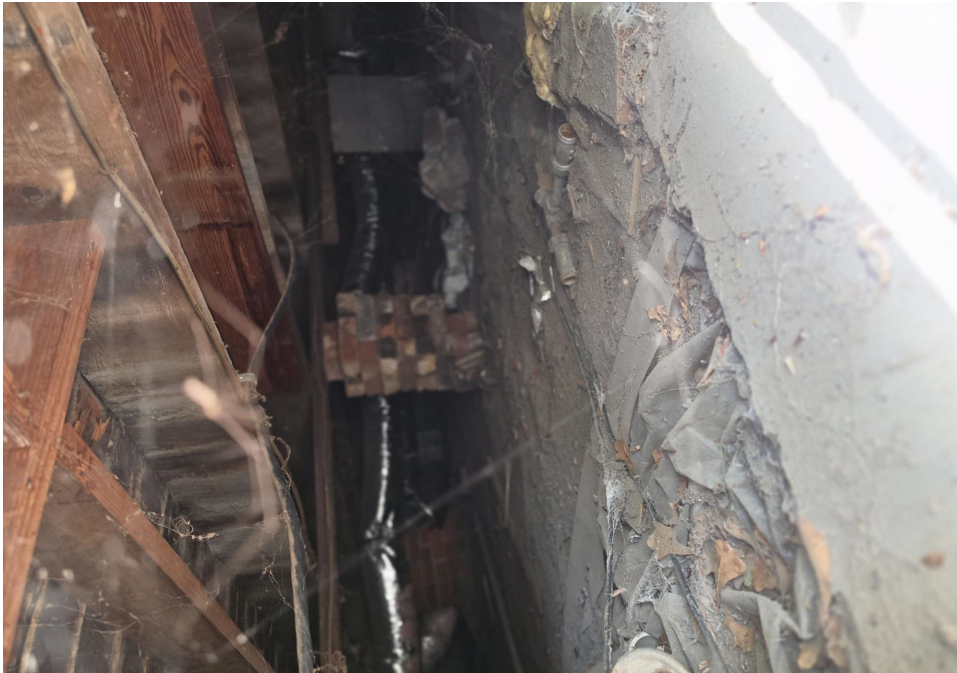
| Suspect Mat. No. | Material Description | Cat. (S,T,M) | Location | Present Cond. | Quantity | Percent Asbestos | Analysis Method |
|---|---|---|---|---|---|---|---|
| 7A-C | Block Mortar | M | Foundation | G/NF | 1100 sq ft | None Detected | PLM<br>EPA/600/R-93/116 |

SM7 - mortar

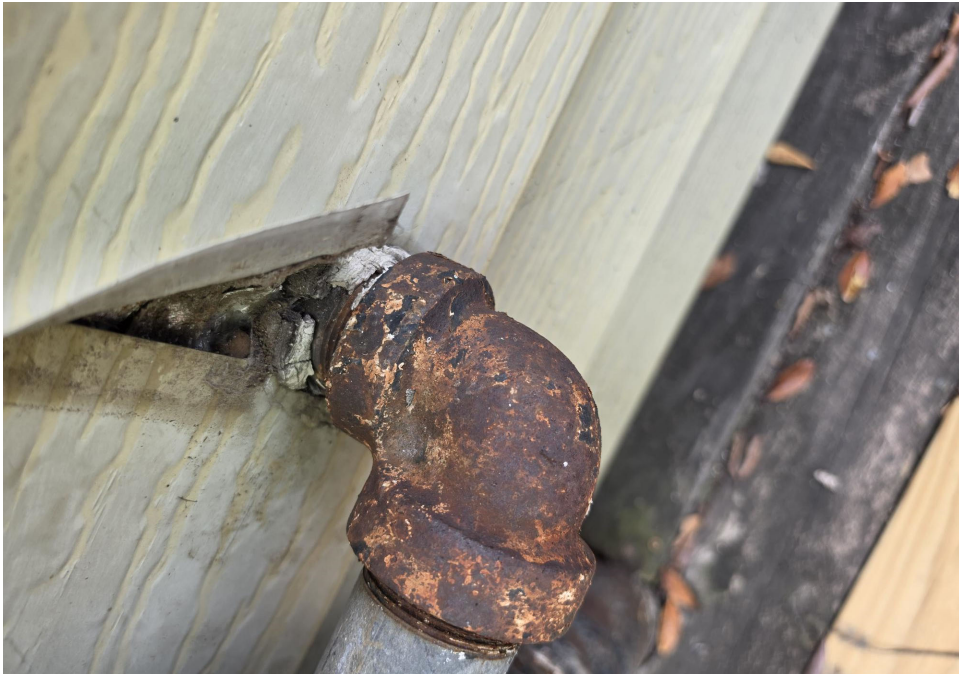
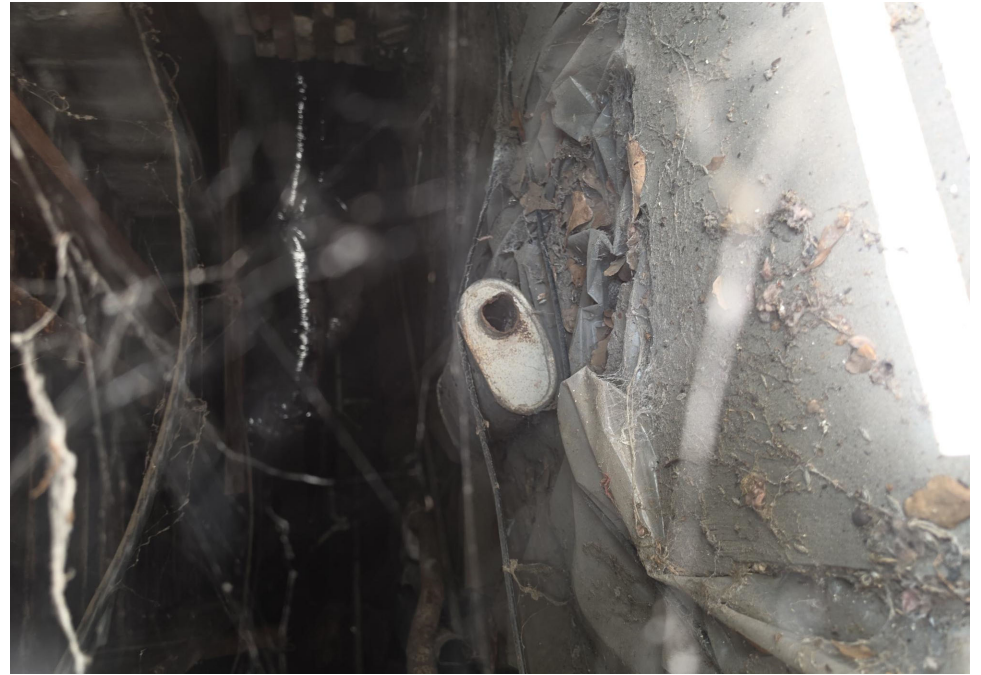
| 9A-C | Pipe Caulking | M | Exterior Pipe on the Backside of the Home | G/NF | 1 ln ft | 4% Chrysotile | PLM<br>EPA/600/R-93/116 & TEM |

SM9 - pipe caulking 4% asbestos
